Consulting Services for Energy Efficiency Options for Existing Homes

Introduction

On January 1, 2016, an energy evaluation was conducted by (*Advisor Name*) at (*insert property information here*), to determine the existing conditions of the cottage. Based on standardized conditions, the following report outlines areas of concerns and recommended upgrades to improve occupant comfort, health and safety, reduce cost of home ownership, and reduce the impact of the building on the environment.

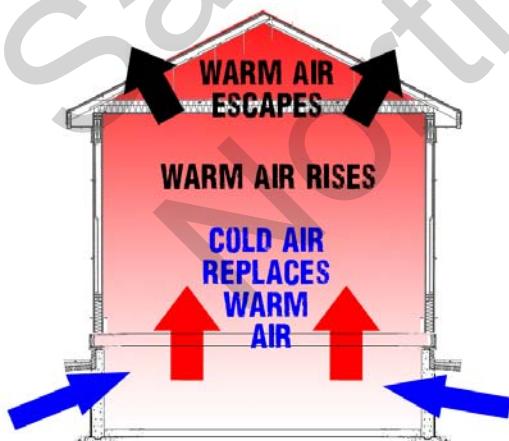
- 2nd floor loft - top right hand side of the cold air duct. Due to this being a cold air return, this heat loss location is allowing the return air to draw the cold air from the attic and allowing warm air to escape.
- Dog door frame.
- Electrical outlets on exterior walls.
- Kitchen hide-away door.
- Pot lights through out ceilings allows warm air to escape.
- PVC lines for water in header to the right of the electrical panel wall allows cold air to enter building.

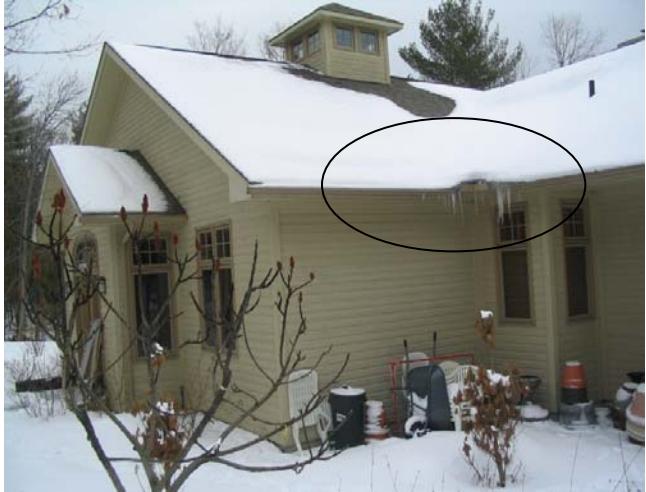
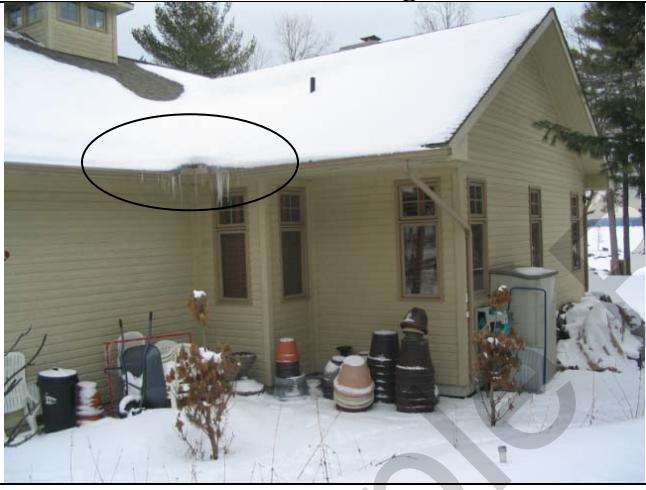
North-West Corner of Cottage

Problem #1 – Ice Damming on Roof

Ice damming is a result of warm air entering the attic space which warms up the exterior roof and melts the snow creating icicles. Damage could result in water backing up under shingles and leaking which would damage the insulation and possibly ceiling finishes.

The second problem with warm air entering the attic space is ... Warm air carries humidity, this humidity condenses once it cools down. (otherwise known as reaching the Dew point, a temperature where water is changed from vapour to a solid form) This water in the winter can be seen with frost forming on the under side of the roof. In the fall and spring this location becomes a great location for mould growth and or wood rot. Correcting the air leakage problem is very important to the environment in the attic.

The result of the air leakage is due to poorly sealed light fixtures and improper insulation values.

- Increase R-Value on all flat ceiling sections by topping up to min. 13 inches for an equivalent R factor of R50. Our recommendation is to install a Blown Cellulose product as it has a better insulation factor and the density of the product helps reduce and control air movement.
- Remove Fibreglass batt insulation from knee walls and replace with either a 2lb Icynene or Polyurethane spray foam, ensuring to cover the top of the air duct and any openings created for the media wiring.
- Check all electrical outlets in the ceiling exposed to the attic and ensure they are sealed with spray foam insulation.
- Once all ceiling work is completed, install a proper attic hatch seal like weather stripping.

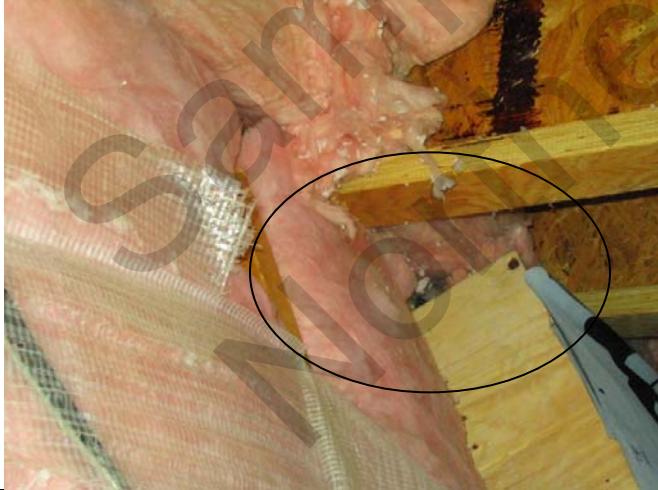
Cold Air Return in Loft

Daylight can be seen in the attic through this space at the top of the cold air return.

The result of the air leakage allows warm air into the attic space which results in condensing.

Added damage results in the furnace drawing very cold air into the system and forcing it to work harder.

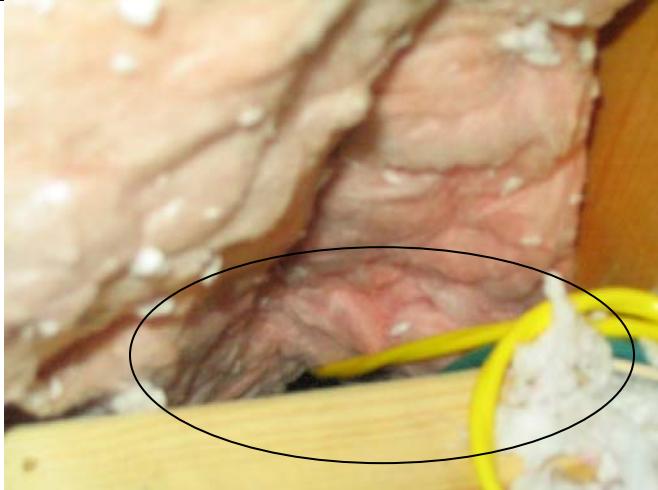
Wiring for TV in Loft

New wiring was added for the entertainment system and the insulation was pulled back and never properly reinstalled which leads to exposing the 2nd floor header and allowing warm air to draw into the attic space.

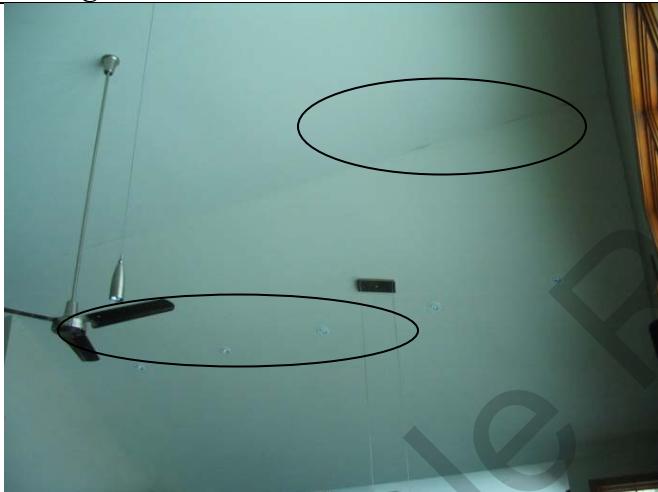
Ceiling Above Great Room

This picture is showing pot lights and drywall tape coming loose. All ceiling fixtures are very leaky causing warm air to leak into the attic space and causing items like the plaster compound to degrade. This is a result of air movement from cold to warm.

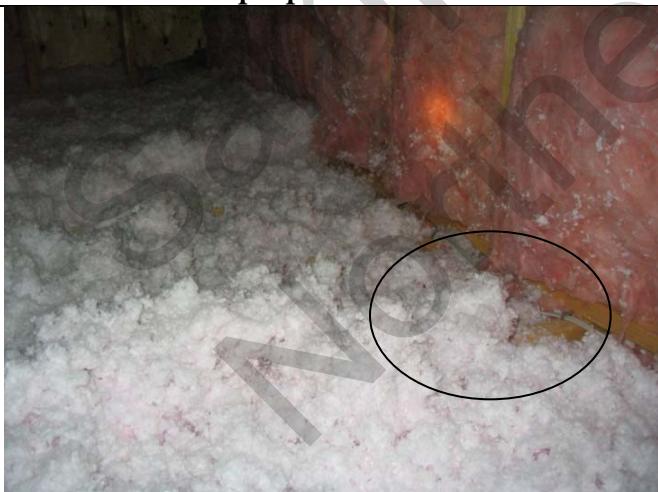
Knee Wall at Loft

R-Value and Insulation

The insulation installed is referred to as Blown Fibreglass. On average we determined the depth of insulation to be at approx. 6 inches which is equivalent to R-20. Our current Building Code requires an insulation value of R-50 which is equivalent to 13 inches.

In each picture we are showing the bottom chord of the truss which is a 2x4 member and shows that in those areas we have even less than the R-20 we determined as an average.

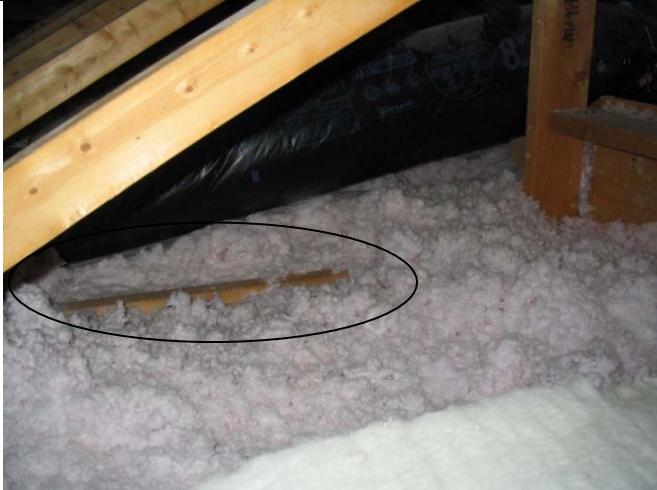
Ceiling Above Mudroom

This improper R-Value and insulation installation causes for heat loss and is a result of the ice damning. It also results in cold rooms which causes discomfort.

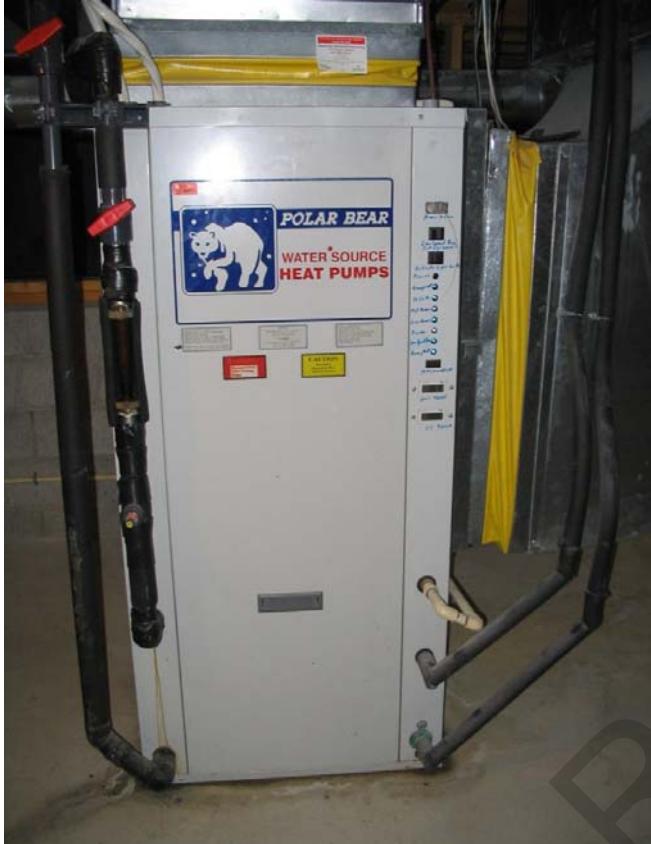
Water Source Heat Pump

Upon review and investigation, it appears the existing mechanical system is in poor working condition. The heating unit continuously runs and is excessively loud. The supplemental storage tanks for the Geothermal system appeared to be in poor condition and possibly leaking as there was pooling of approx. $\frac{1}{2}$ " of water lying in the bottom of the unit. Rust minerals were very noticeable around the tanks.

The HRV (heat recovery ventilator) appeared to be not operating properly and was not running at time of our investigation. There could possibly be a wiring issue as the breaker was tripped and when we turned it back on the HRV did run. It also appeared that the thermostat on the main floor which operates the HRV was not setup to turn it on and off.

It is highly recommended that a licensed mechanical contractor and a certified HVAC designer review and complete heat loss calculations and proper duct sizing for either the existing system or a new heating system before making any alterations. Temperature tests were performed on multiple heat register locations and temperatures differed by as much as 20 degrees which leads to either improper duct sizing or improper damper settings.

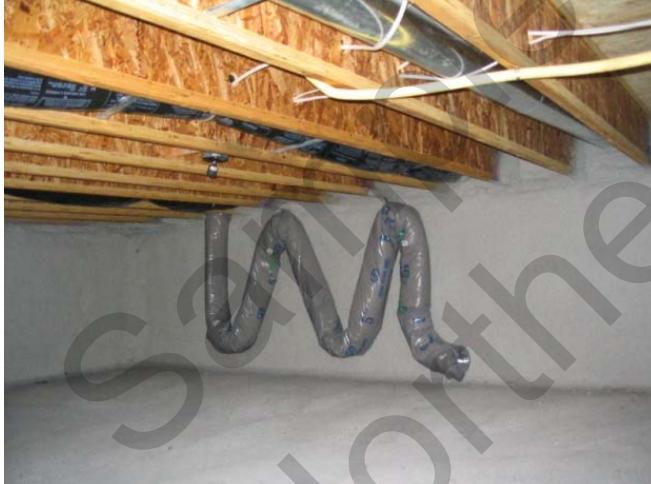
Saskatoon Loop

The home is equipped with a "Saskatoon Loop" which is added to some homes when there is a demand due to stack effect or fan depressurization. The premise behind this idea is that since cold air falls down such air inlets because it is heavy, it pools at the base of the loop and prevents flow until an exhaust fan creates an air demand. But cold air does not fall down ducts or chimneys because it is heavy; it is sucked down by stack effect or fan depressurization. The Combustion Safety test was performed and failed as it exceeded -5Pa (result is -8.8Pa) which determines a certified HVAC designer needs to ensure proper makeup air is calculated in the design.

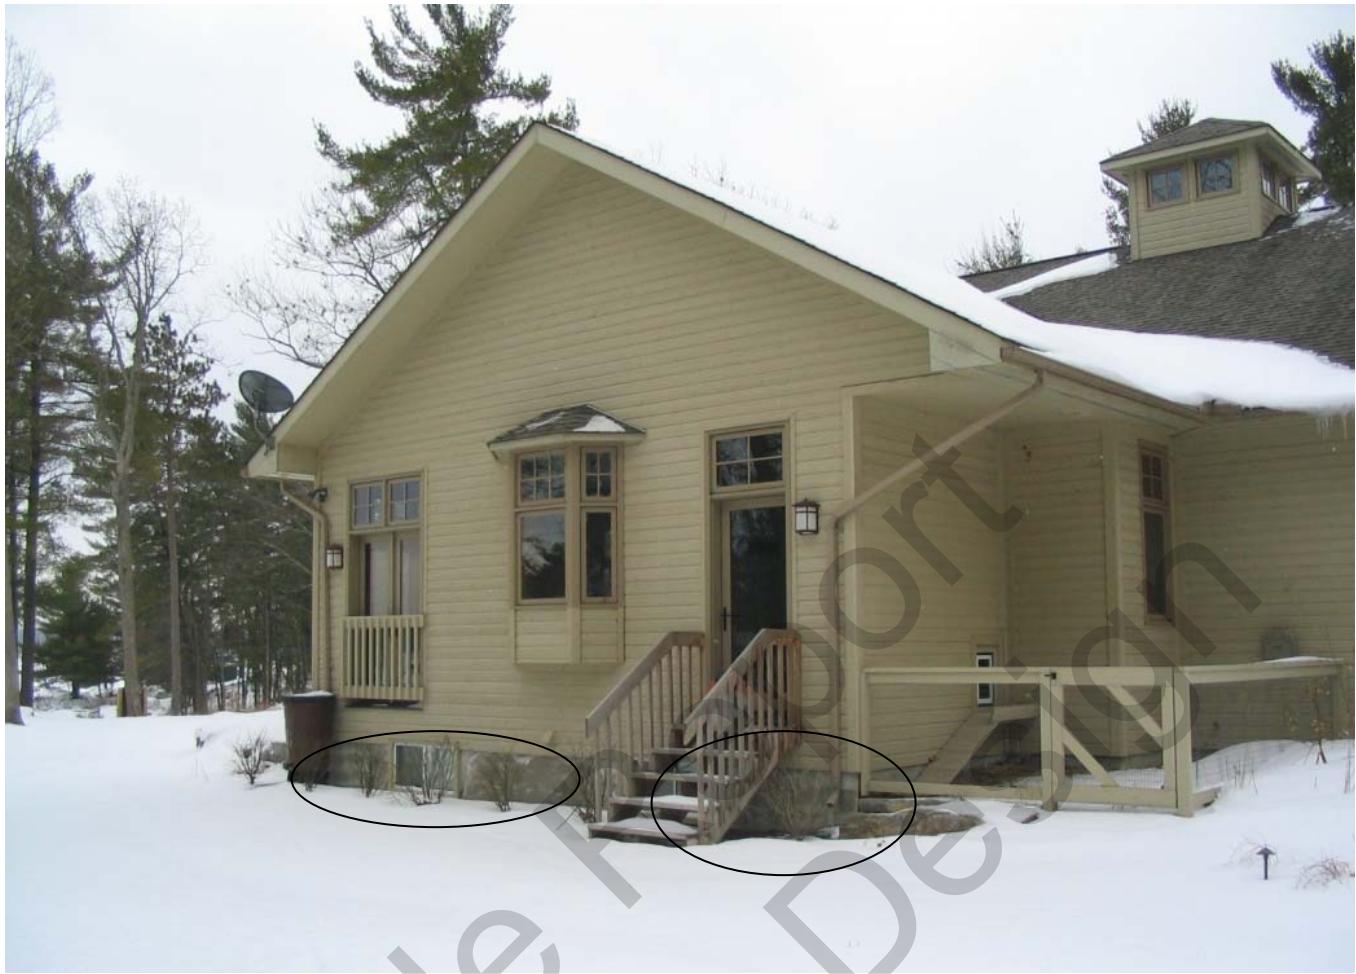
Water Damage on Foundation

The foundation wall along the east side has extensive white powder like stains which is referred to as Efflorescence as well as it's very wet above grade. Despite its solid form, concrete is designed to allow water to pass through it freely. When concrete is in continuous contact with damp, wet earth, a portion of that moisture is continually going to enter the concrete, making its way through the micropores in the concrete.

As water passes through the concrete, it brings minerals with it. The moisture then evaporates into the basement, leaving these minerals behind. Due to the basement being insulated with a closed cell spray foam, it is not allowing the proper evaporation which is causing the foundation to remain wet. Over time, the buildup on the concrete creates the efflorescence that you see. This is happening because the eaves trough has no extension to dissipate away from the building and is depositing water directly to the concrete. It is recommended that extensions be installed at least 4 to 6 feet away from the building.

The constant wetness of the foundation may also be caused by poor materials backfilled like clay which holds water and does not drain properly. Another recommendation is to excavate the existing materials and import sand fill then top off with top soil. Inspection of dampproofing and perimeter drain at footing would be suggested while it's opened up.
