Consulting Services for Energy Efficiency Options for Existing Homes

Introduction

On January 1, 2016, an energy evaluation was conducted by (*Advisor Name*) at (*insert property information here*), to determine the existing conditions of the cottage. Based on standardized conditions, the following report outlines areas of concerns and recommended upgrades to improve occupant comfort, health and safety, reduce cost of home ownership, and reduce the impact of the building on the environment.

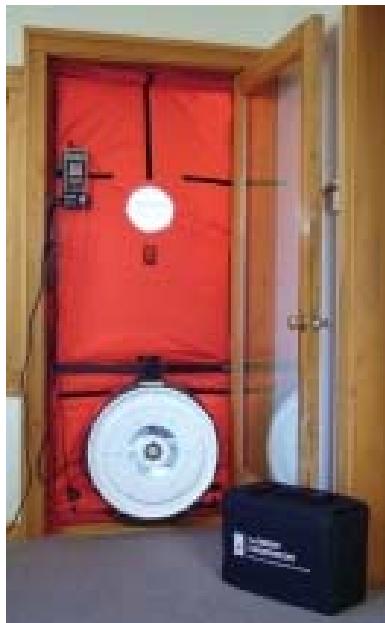
Air Leakage Loss

By conducting a Blower Door Test, we were able to measure the amount of air leakage through the buildings envelope. By calculating air loss, we were able to determine that the home has many small holes which when added all together gave an area of approx. 169 sq. in.

This area is determined by adding all the cracks and holes in the buildings envelope, which would be comparable to having a hole that is 13 inches x 13 inches in size and is equivalent to a picture frame.
